# DRAFT DRAFT DRAFT Everything That Went Wrong For UBC Solar At FSGP 2025

Christopher Kalitin Blog (<https://ckalitin.github.io/posts/ubc-fsgp-2025/>)

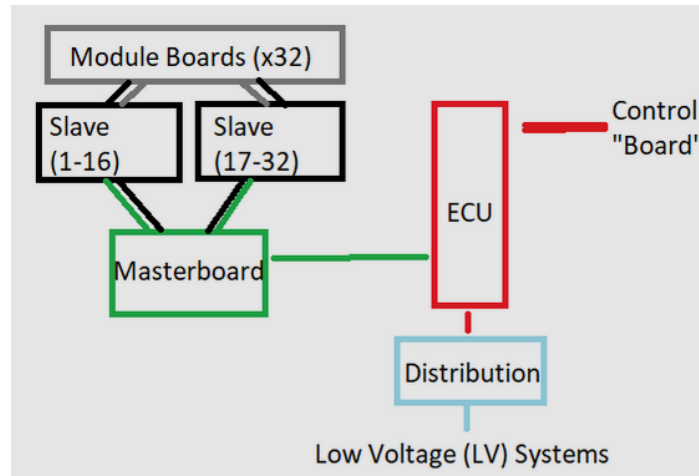
Our BMS architecture.

The first issue we saw is that some module voltage readings\* were lower or higher than expected. On modules 21 and 22 we saw anomolous voltage reads that did not match the rest of the modules which were  $\sim 4.1$  V. Depending on how the wire from the cell board (which holds the thermistor) to the slave board (which has the microcontroller reading voltage and temperature) was bent or if we touched it, we got a different voltage reading. Sometimes a module showed 1V, sometimes it was fine, sometimes it was  $>\sim 4.1$  V.

After replugging in all of the cellboard-to-slaveboard wire harnesses, replugging the isoSPI wire from the BMS masterboard to slaveboard and poking around the pack we came to the conclusion that we had several distinct issues.

1. Touching the isoSPI wire harness between the masterboard and slaveboard 1 resulted in different data
2. Touching the slaveboards at certain points resulted in different data
3. Touching the slaveboard-cellboard wire harness sometimes resulted in different data

Our process for solving this issue involved replacing one of our slaveboards with a replacement we brought up before competition. Replacing it again with a mostly complete (missing LTC6813 micro controller) slave board again. Replacing one of the MOSFETs that toggle the balancing resistor. And swapping out the slaveboard-cellboard wire harnesses and masterboard-slaveboard isoSPI wire a few times.
